# 2022 Aquatic Vegetation Survey: Project and Results

# Little Sand Lake

## Aquatic Vegetation Mapping and Monitoring – *an ongoing project*

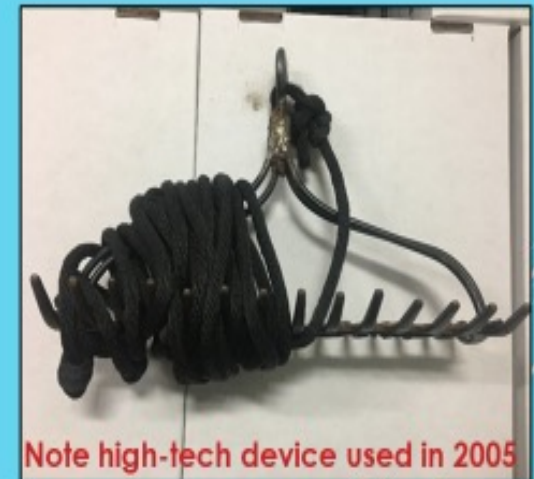
- **“Circling the Bulrushes & Lily Pads”**
- **Three Old Codgers (Gone High Tech)**
  - Jim Thomsen, Vern Thompson & Dan Kittilson
- **Throwing Rakes and Arguing about Plant ID While Sampling Submerged Vegetation**
- **Joint Partnership with DNR in 2005-06**
- **Joint Partnership with HC COLA & Other Area Lakes**
- **Utilizing GPS/GIS, Edie Evarts develops color-coded maps showing Emergent & Floating Leaf Vegetation**

Note high-tech device used in 2005

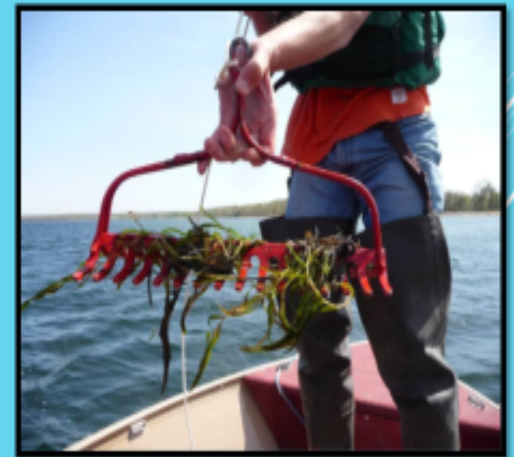
- Followed RMBEL and DNR Standard Operating Procedures for Point Intercept Surveys.
- Points surveyed previously were projected in the boat's GPS system.
- Double-headed, weighted garden rake attached to a rope was used to survey vegetation.
- Observations also made visually and with sonar.
- Vegetation found under the surface by use of the rake was categorized as follows:
  - 0 = absent,
  - 1 = rare ( $\leq 1/3$  of the rake head covered),
  - 2 = scattered ( $>1/3$  but  $\leq 2/3$  of the rake head covered),
  - 3 = common ( $>2/3$  of the rake head covered), and
  - 4 = abundant (plants over top of rake head).
- Plant identification followed Blickenderfer (2007)

*Same high-tech device as used in 2008.*

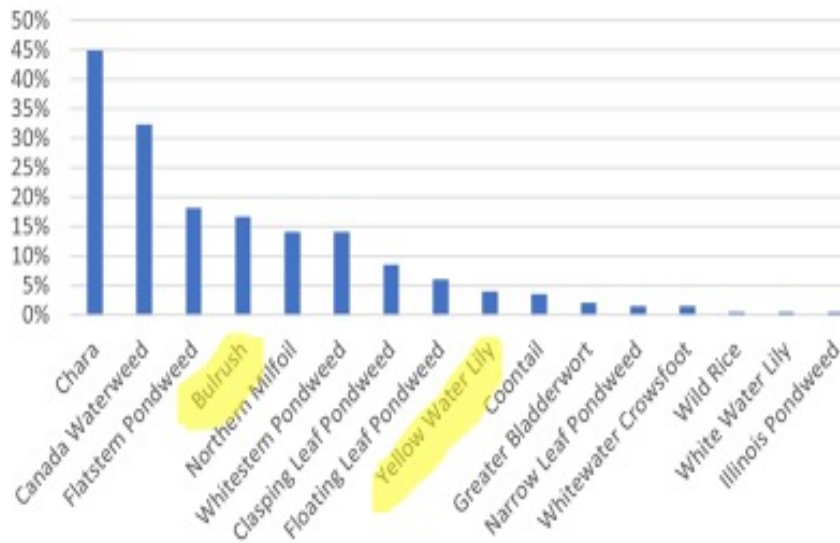
Species Abundance - Little Sand Lake

Emergent, Floating, and Submerged

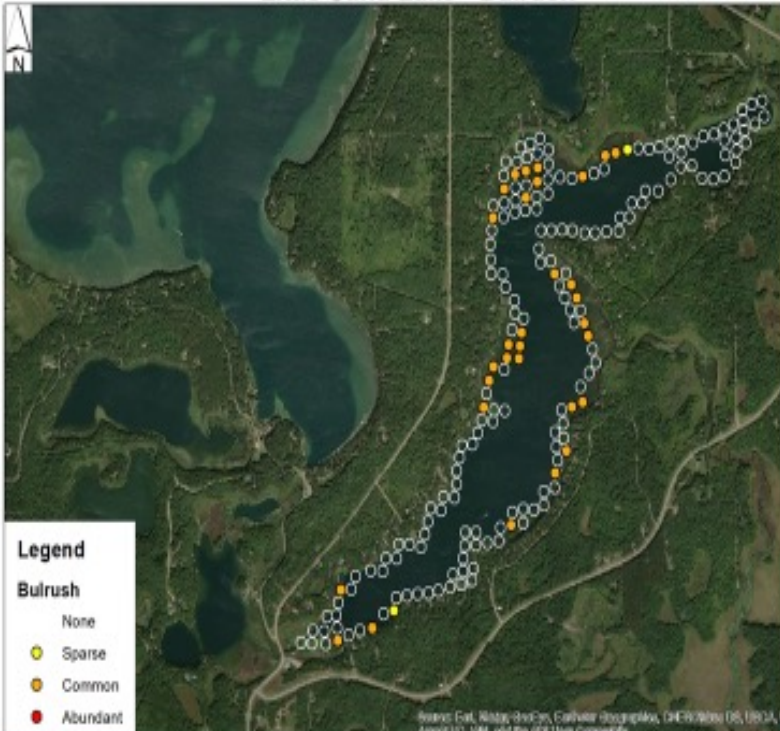
Little Sand Lake - Bulrush

Bulrush is an emergent species

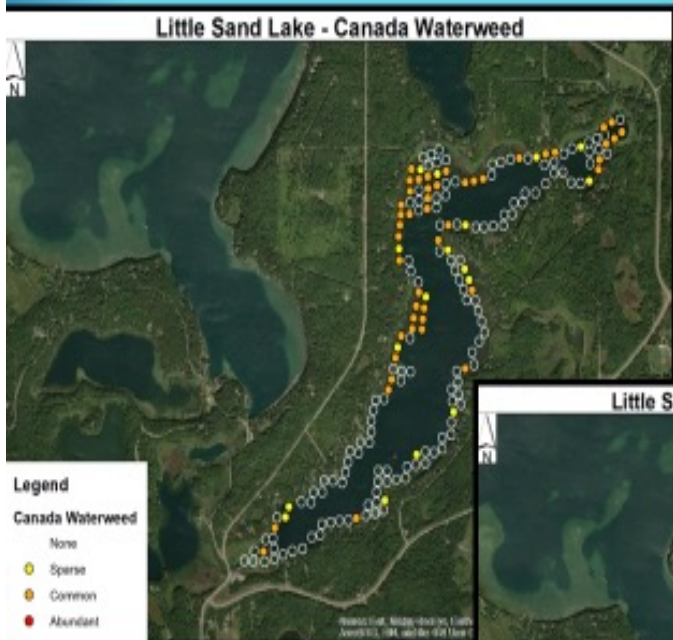
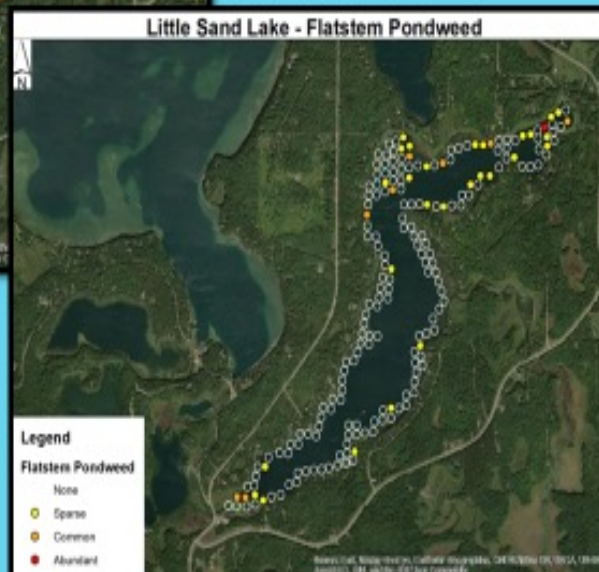
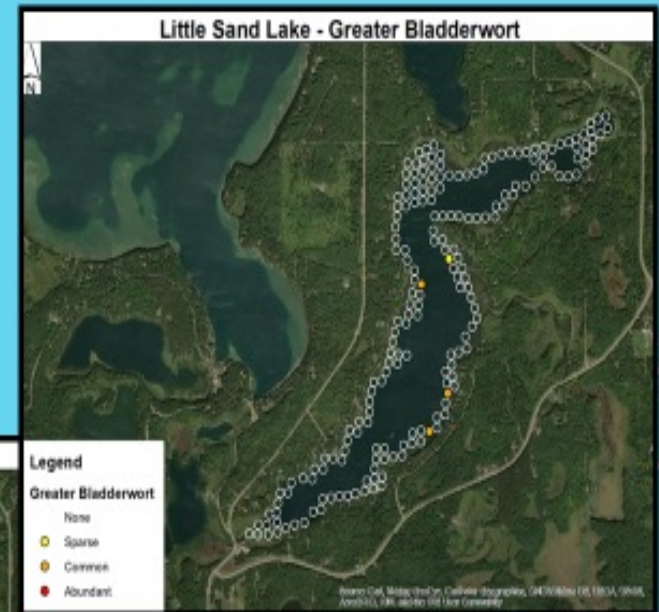
Received maps by species that showed the density of the species at each point.  
A few examples:

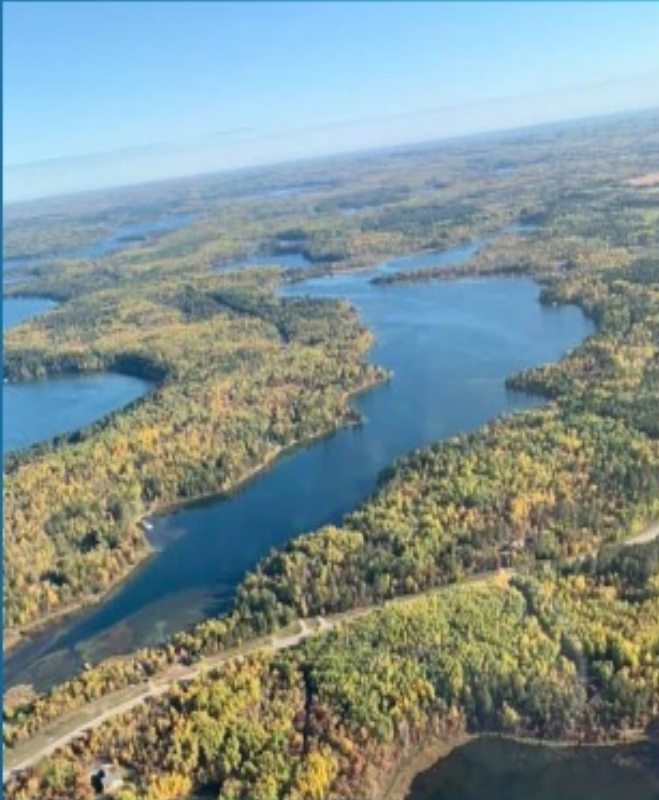
- The presence of plants and the depth at which one finds them is related to the water clarity.
- The Minnesota DNR lists the littoral area of Little Sand Lake to be approximately 36% of the total surface area, and the findings of this plant survey support these findings.
- In general, the littoral area is approximated as the area of the lake that is 15 feet deep or less; in this plant survey, no plants were found deeper than 16 feet.
- While sampling was focused in the littoral area, actual depths encountered ranged up to 20 feet.

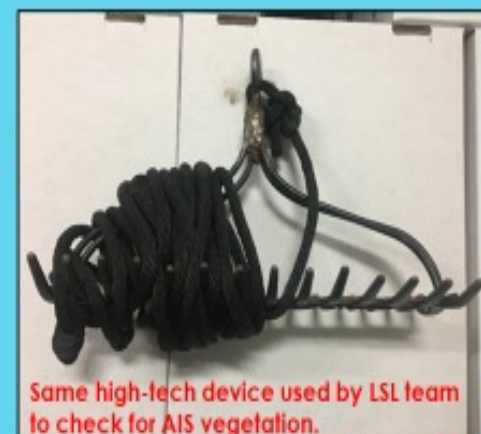
Same high-tech device used by LSL team to check for AIS vegetation.
